**Flood Control Project Maintenance  
Levee Inspections**  
**LMA District Cover Sheet**  
**Spring 2018 Levee Inspection Results**

**City of Sacramento**

**Spring 2018 Levee Inspection Results**

Waterway			Bank	Unit Miles
Unit No. 01 Sacramento River			Left	3.67
	Spring (March - May)	Summer (June - August)	(September - November) Fall	Winter (December - February)
Unit Maintenance Rating (Fall Only)				
Date of Inspection	3/20/2018 - 3/20/2018			
DWR Inspector	Zach Jojola			
Accompanied By	Adam Strebel City of Sacramento

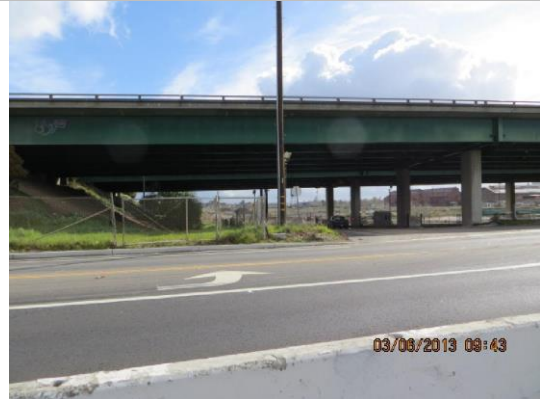
Photo 1 of 3 : UCIP\_SP\_2018\_49955\_33806.jpg

View of levee crown at crossing--sign visible on landward side near freeway underpass.

Comment Code						
Inspector Comment						
FS_ID:49955 DS_ID:21559 EP_NO: 14527 Repair Type: Non-Urgent Crossing Status: Found UCIP Comments: 07/21/2016 Meet with City of Sacramento North Area Drainage representatives: Mick Smith and Mike Gonsalves. LMA has been coordinating with owner and according to their records this pipe is a PG&E line. PG&E contact is Don Triplet and can be reached at 1-559-493-8007 or by email at DxTb@pge.com. LMA is working with the CVFPB to obtain status information. (DWR UCIP – O. Magana) 7/19/2016 Paddle marker missing from WS--owner will need to work with CVFPB to determine if paddle marker on WS is necessary. (DWR UCIP - omagana)3/22/2016 Need to contact owner to determine condition of crossing and last inspection date. (DWR UCIP - omagana) FIELD_STRUCT_DESC: 12.75-inch steel gas line through levee (right bank), unable to confirm depth below the crown. Permit indicates the pipeline shall be buried with a minimum cover of 1 feet in the levee slopes and 2 feet through the levee crown. Line was directionally bored under the left bank levee and low water channel at a minimum cover of 44 feet and 21 feet, respectively. Paddle marker located approximately 150 feet from levee crown on landside (LS). (12.75-inch line authorized under Permit No. 14527, 1987 - Southern Pacific Pipelines, Inc.) [Additional Reference(s): DWR Levee Log, 1993] FS Date: 7/19/2016

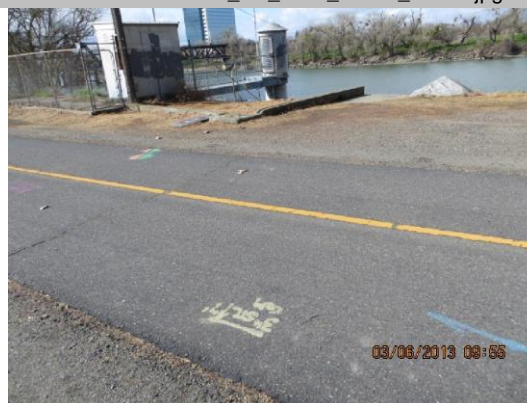
Photo 1 of 3 : UCIP\_SP\_2018\_41414\_72622.jpg

Comment Code					
Inspector Comment					
FS_ID:41414 DS_ID:24882 EP_NO: N/A Repair Type: Non-Urgent Crossing Status: Indicator Found UCIP Comments: 07/21/2016 Meet with City of Sacramento North Area Drainage representatives: Mick Smith and Mike Gonsalves. LMA engineer is investigating how to conduct inspection and defining levee toe. (DWR UCIP - O. Magana) 03/06/2013 Need to contact owner to determine status of crossing. No permit found during desk study review. (DWR UCIP - O. Magana) FIELD_STRUCT_DESC: 42-inch water transmission main of unknown material through levee at unknown depth. Crossing installed in 1966. Crossing installed in the 1930s according to LMA engineer and not 1966. FS Date: 3/6/2013

View of levee crown and waterward side.

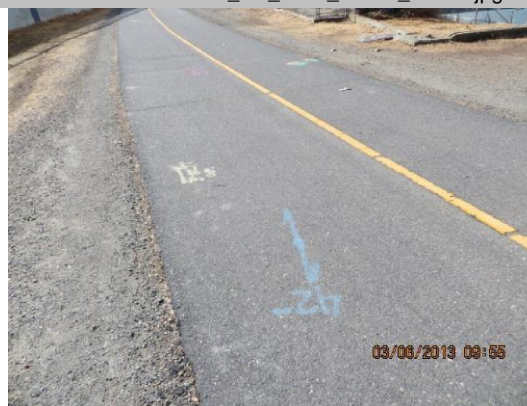
Photo 3 of 3 : UCIP\_SP\_2018\_41414\_72620.jpg

Comment Code						
Inspector Comment						
FS_ID:41414 DS_ID:24882 EP_NO: N/A Repair Type: Non-Urgent Crossing Status: Indicator Found UCIP Comments: 07/21/2016 Meet with City of Sacramento North Area Drainage representatives: Mick Smith and Mike Gonsalves. LMA engineer is investigating how to conduct inspection and defining levee toe. (DWR UCIP - O. Magana) 03/06/2013 Need to contact owner to determine status of crossing. No permit found during desk study review. (DWR UCIP - O. Magana) FIELD_STRUCT_DESC: 42-inch water transmission main of unknown material through levee at unknown depth. Crossing installed in 1966. Crossing installed in the 1930s according to LMA engineer and not 1966. FS Date: 3/6/2013

View of alignment along levee.

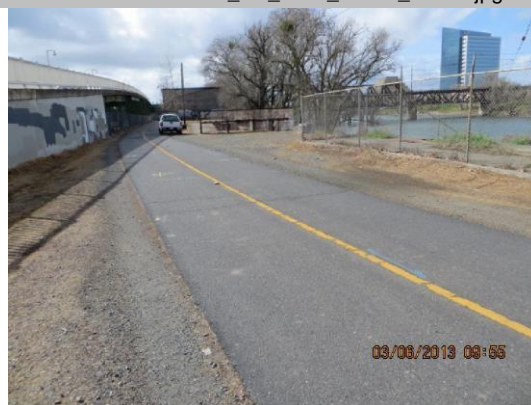
Photo 2 of 2 : UCIP\_SP\_2018\_41415\_72623.jpg

LM Start	0.14	Rating **	M	Issue No.	100
LM End	0.14	Issue Type +	En	Location *	
Category	Supplemental			GPS Latitude/Longitude	
				Start	End
Item	DWR UCIP Field Study			38.588738 °	38.588738 °
				-121.504891 °	-121.504891 °
DWR ID					
Comment Code					
Inspector Comment					
FS_ID:41415 DS_ID:24883 EP_NO: N/A Repair Type: Non-Urgent Crossing Status: Indicator Found UCIP Comments: 07/21/2016 Meet with City of Sacramento North Area Drainage representatives: Mick Smith and Mike Gonsalves. No Additional information was made available regarding the fate of this crossing. (DWR UCIP – O. Magana) 03/06/2013 Need to contact owner to confirm alignment and status of crossings. No permit found during desk study review. (DWR UCIP - O. Magana) FIELD_STRUCT_DESC: ARV communication line and 3-inch steel communication line through levee at unknown depth below the levee crown. FS Date: 3/6/2013

Overview of levee crown looking downstream.

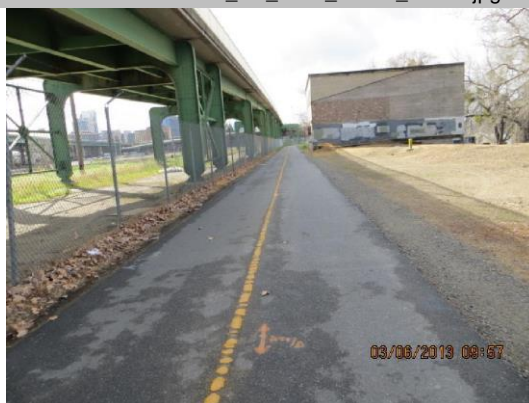
Photo 1 of 2 : UCIP\_SP\_2018\_41416\_72629.jpg

Comment Code					
Inspector Comment					
FS_ID:41416					
DS_ID:24885					
EP_NO: N/A					
Repair Type: Non-Urgent					
Crossing Status: Indicator Found					
UCIP Comments: 07/21/2016 Meet with City of Sacramento North Area					
Drainage representatives: Mick Smith and Mike Gonsalves. Crossing					
belongs to AT&T. AT&T contact is Astrid Willard Manager Public Works					
Director of State R/R and can be reached at 916-971-3961 or by email					
at astrid.willard@att.com. (DWR UCIP – O. Magana)					
03/06/2013 No markers visible as per Title 23. Recommend having					
utility owner coordinate with Central Valley Flood Protection Board					
(CVFPB). (DWR UCIP - O. Magana)					
FIELD_STRUCT_DESC: ATT communication line through levee at					
unknown depth.					
FS Date: 3/6/2013

Alignment of communication line through levee, Photo 1 of 2.

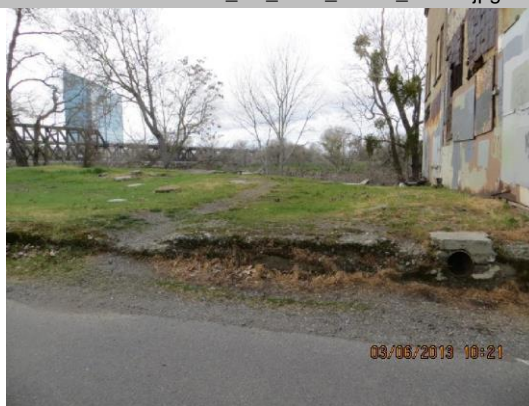
Photo 2 of 3 : UCIP\_SP\_2018\_40848\_72632.jpg

Comment Code						
Inspector Comment						
FS_ID:40848						
DS_ID:24887						
EP_NO: N/A						
Repair Type: Non-Urgent						
Crossing Status: Indicator Found						
UCIP Comments: 07/21/2016 Meet with City of Sacramento North Area						
Drainage representatives: Mick Smith and Mike Gonsalves. Pipe is						
installed above crown. (DWR UCIP – O. Magana)						
03/06/2013 Pump station appears non-functional. Owner will need to						
coordinate with DWR-Inspector and CVFPB to determine if crossing						
meets Title 23 requirements. (DWR UCIP - O. Magana)						
FIELD_STRUCT_DESC: 12-inch steel drainage pipe connected to 10						
inch pipe through levee at unknown depth.						
FS Date: 3/6/2013

View of levee crown at crossing.

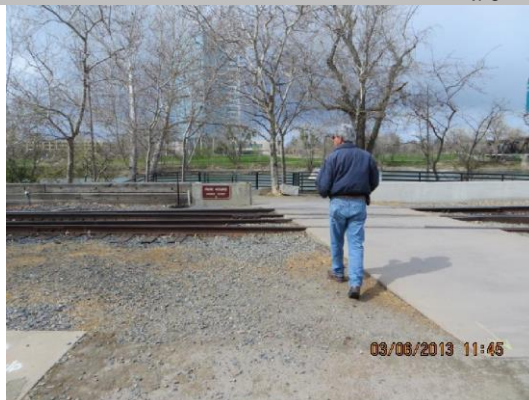
Photo 1 of 3 : UCIP\_SP\_2018\_20384\_34410.jpg

Comment Code					
Inspector Comment					
FS_ID:20384 DS_ID:21561 EP_NO: N/A Repair Type: Non-Urgent Crossing Status: Indicator Found UCIP Comments: 07/21/2016 Meet with City of Sacramento North Area Drainage representatives: Mick Smith and Mike Gonsalves. Internal inspection expected in August 2016 by the City of Sacramento. (DWR UCIP – O. Magana) 03/06/2013 Only manhole was visible; need to determine condition of crossing; Will need to follow up with the City of Sacramento. (DWR UCIP - O. Magana) FIELD_STRUCT_DESC: 18-inch drainage pipe of unknown material through the levee, 5 feet below the levee crown. Concrete surge box on the waterside (WS) of the retaining wall. Concrete box spillway. [Additional Reference(s): DWR Levee Log, 1993] FS Date: 3/6/2013

View of levee crown downtown Sacramento--wide crown with railroad.

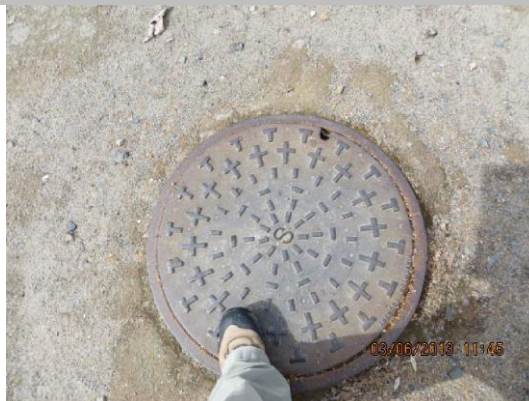
Photo 2 of 3 : UCIP\_SP\_2018\_20384\_34409.jpg

View of manhole located at the edge of waterward.

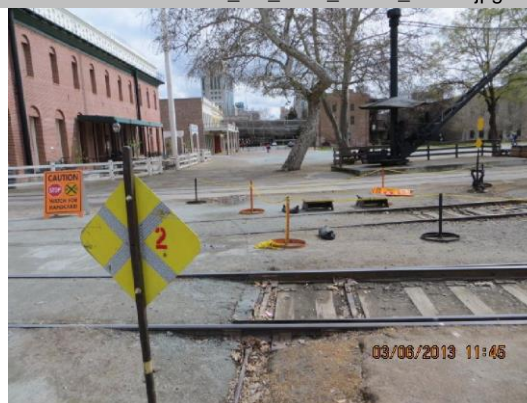
Photo 3 of 3 : UCIP\_SP\_2018\_20384\_34408.jpg

Comment Code						
Inspector Comment						
FS_ID:20384 DS_ID:21561 EP_NO: N/A Repair Type: Non-Urgent Crossing Status: Indicator Found UCIP Comments: 07/21/2016 Meet with City of Sacramento North Area Drainage representatives: Mick Smith and Mike Gonsalves. Internal inspection expected in August 2016 by the City of Sacramento. (DWR UCIP – O. Magana) 03/06/2013 Only manhole was visible; need to determine condition of crossing; Will need to follow up with the City of Sacramento. (DWR UCIP - O. Magana) FIELD_STRUCT_DESC: 18-inch drainage pipe of unknown material through the levee, 5 feet below the levee crown. Concrete surge box on the waterside (WS) of the retaining wall. Concrete box spillway. [Additional Reference(s): DWR Levee Log, 1993] FS Date: 3/6/2013

View of landward side close to railroad museum.

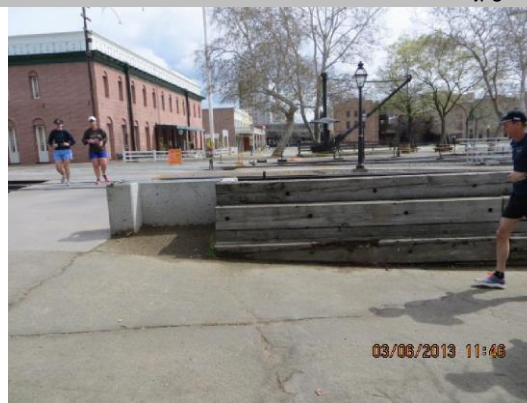
Photo 3 of 3 : UCIP\_SP\_2018\_41417\_72640.jpg

Comment Code						
Inspector Comment						
FS_ID:41417 DS_ID:24890 EP_NO: N/A Repair Type: Non-Urgent Crossing Status: Indicator Found UCIP Comments: Need additional information about crossing--depth of pipe, owner, status, and permit. FIELD_STRUCT_DESC: Submarine cable from the bed of the Sacramento River through and along the natural west levee of the river at a depth of 2 feet to a point in the town of Broderick, opposite a point approximately 434 feet downstream from the "I" Street Bridge, Sacramento. (submarine cable across river approximately 434 feet downstream from the "I" Street Bridge authorized under Permit No. 881, 1942 - The Pacific Telephone & Telegraph Company [PT&T]; installation and maintenance of an armored submarine cable in, and under and across river authorized under Permit No. 1628, 1952 - PT&T) FS Date: 3/6/2013

View of landward side.

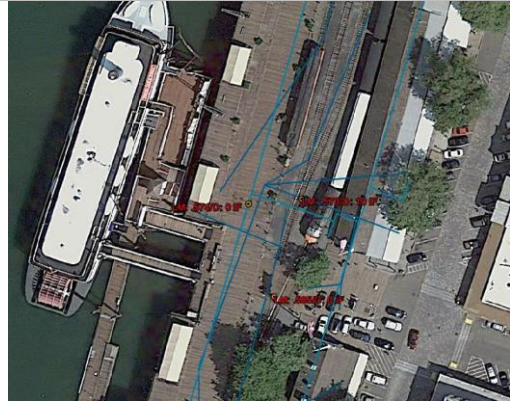
Photo 1 of 1 : UCIP\_SP\_2018\_41419\_72742.jpg

Comment Code					
Inspector Comment					
FS_ID:41419 DS_ID:24895 EP_NO: N/A Repair Type: Non-Urgent Crossing Status: Indicator Found UCIP Comments: 06/06/2017 Received documentation from the City of Sacramento indicating that this crossing was internally inspected on 10/28/2013, PACP Sewer Report was provided. PACP report is missing rating evaluation. No additional information was received from the City of Sacramento. Need to request evaluation of pipe (integrity of pipe section through the levee) and find out when the City is planning the next internal inspection for this pipe. (DWR UCIP – O. Magana) 03/06/2013 Need to confirm if crossing is still present. No signs visible during site visit. No photos available. FIELD_STRUCT_DESC: 10-inch vitrified clay drainage pipe through levee at an unknown depth. Record was obtained from the City of Sacramento's kml file with approximate utility alignment. FS Date: 3/6/2013

Approximate alignment provided by the City of Sacramento--unable to confirm crossing in field.

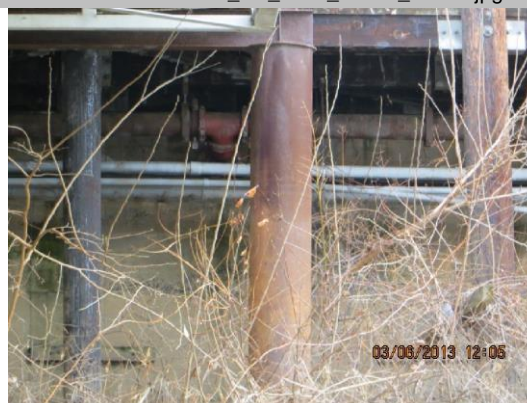
Photo 1 of 1 : UCIP\_SP\_2018\_41263\_72744.jpg

LM Start	0.59	Rating **	M	Issue No.	114
LM End	0.59	Issue Type +	En	Location *	
Category	Supplemental			GPS Latitude/Longitude	
				Start	End
Item	DWR UCIP Field Study			38.582482 °	38.582482 °
				-121.506346 °	-121.506346 °
DWR ID					
Comment Code					
Inspector Comment					
FS_ID:41263					
DS_ID:24897					
EP_NO: N/A					
Repair Type: Non-Urgent					
Crossing Status: Indicator Found					
UCIP Comments: Need to contact owner. Need to determine permit issued for crossing.					
FIELD_STRUCT_DESC: 8 -10 inch pipe through levee.					
FS Date: 3/6/2013

Pipe through floodwall.

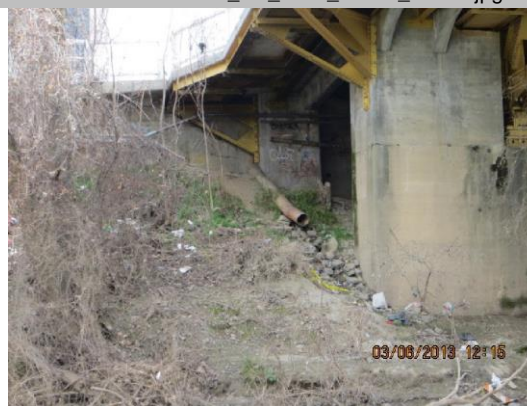
Photo 1 of 3 : UCIP\_SP\_2018\_41421\_72750.jpg

View of waterward side.

Comment Code						
Inspector Comment						
FS_ID:41421 DS_ID:24905 EP_NO: N/A Repair Type: Non-Urgent Crossing Status: Indicator Found UCIP Comments: 07/21/2016 Meet with City of Sacramento North Area Drainage representatives: Mick Smith and Mike Gonsalves. This crossing appears to be a Caltrans pipe and is part of the permit for the Bridge. Pipe might not go through levee. Need to pull Bridge permit to review As-built drawings. (DWR UCIP – O. Magana) 03/06/2013 Need to contact owner to determine status and permit number for crossing. (DWR UCIP - O. Magana) FIELD_STRUCT_DESC: Corrugated metal drainage pipe through floodwall visible on waterside (WS). FS Date: 3/6/2013

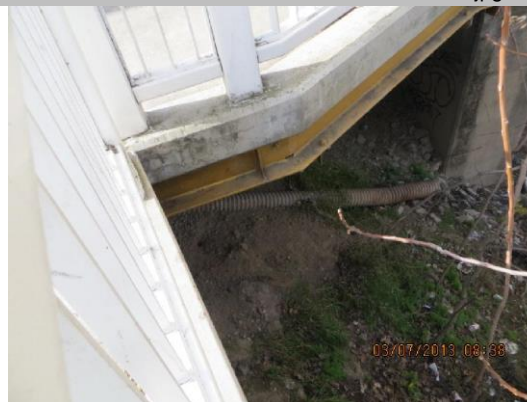
Photo 2 of 3 : UCIP\_SP\_2018\_41421\_72749.jpg

Pipe visible on waterward side.

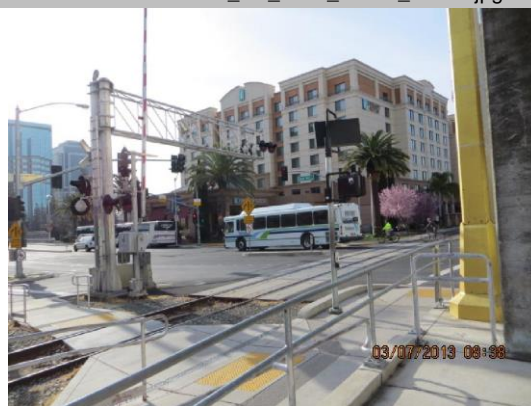
Photo 3 of 3 : UCIP\_SP\_2018\_41421\_72748.jpg

View of general area immediately downstream from crossing.

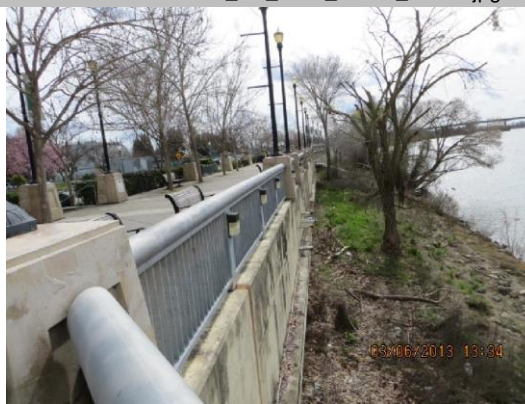
Photo 1 of 3 : UCIP\_SP\_2018\_41422\_72754.jpg

LM Start	0.81	Rating **	M	Issue No.	125
LM End	0.81	Issue Type +	En	Location *	
Category	Supplemental			GPS Latitude/Longitude	
				Start	End
Item	DWR UCIP Field Study			38.579353 °	38.579353 °
				-121.507560 °	-121.507560 °
DWR ID					
Comment Code					
Inspector Comment					
FS_ID:41422					
DS_ID:24908					
EP_NO: N/A					
Repair Type: Non-Urgent					
Crossing Status: Indicator Found					
UCIP Comments: 07/21/2016 Meet with City of Sacramento North Area					
Drainage representatives: Mick Smith and Mike Gonsalves. No					
Additional information was made available through the LMA. (DWR					
UCIP – O. Magana)					
03/06/2013 Need to contact owner to determine status, purpose for					
lines, and permit number. (DWR UCIP - O. Magana)					
FIELD_STRUCT_DESC: Cluster of conduits through floodwall visible					
from waterside (WS).					
FS Date: 3/6/2013

View of levee just downstream from crossings.

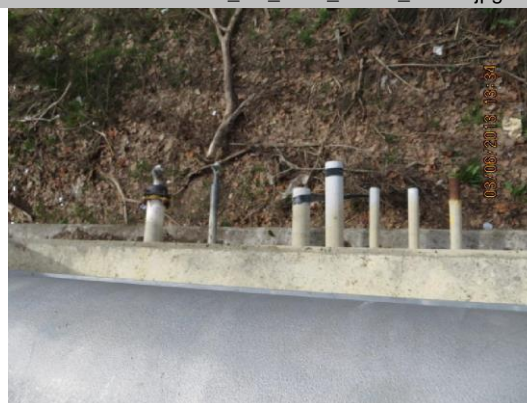
Photo 2 of 3 : UCIP\_SP\_2018\_41422\_72753.jpg

LM Start	0.81	Rating **	M	Issue No.	125 (cont)	
LM End	0.81	Issue Type +	En	Location *		
Category	Supplemental			GPS Latitude/Longitude		
				Start		End
Item	DWR UCIP Field Study			38.579353 °		38.579353 °
				-121.507560 °		-121.507560 °
DWR ID						
Comment Code						
Inspector Comment						
FS_ID:41422						
DS_ID:24908						
EP_NO: N/A						
Repair Type: Non-Urgent						
Crossing Status: Indicator Found						
UCIP Comments: 07/21/2016 Meet with City of Sacramento North Area						
Drainage representatives: Mick Smith and Mike Gonsalves. No						
Additional information was made available through the LMA. (DWR						
UCIP – O. Magana)						
03/06/2013 Need to contact owner to determine status, purpose for						
lines, and permit number. (DWR UCIP - O. Magana)						
FIELD_STRUCT_DESC: Cluster of conduits through floodwall visible						
from waterside (WS).						
FS Date: 3/6/2013

Conduits through floodwayll.

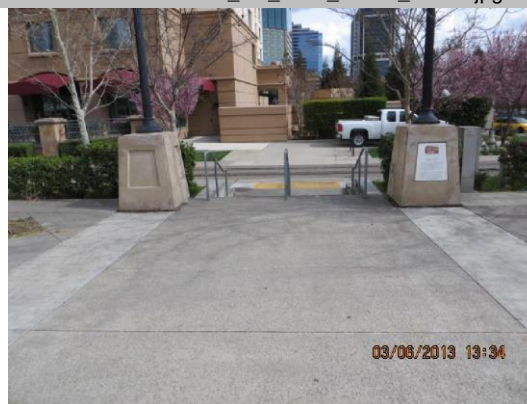
Photo 3 of 3 : UCIP\_SP\_2018\_41422\_72752.jpg

View of landward side.

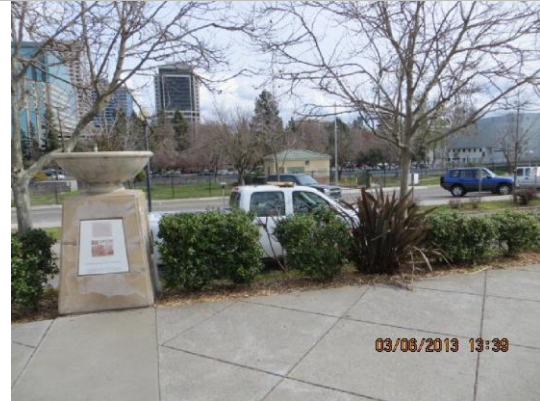
Photo 1 of 3 : UCIP\_SP\_2018\_52601\_34414.jpg

07/21/2016 Meet with City of Sacramento North Area Drainage representatives: Mick Smith and Mike Gonsalves. Mike Gonsalves mentioned that inspection completed in 2016 by Caltrans revealed structure needed some repairs. Caltrans is working at replacing/repairing pipe by 2018. (DWR UCIP – O. Magana)  
FIELD\_STRUCT\_DESC: [O Street Outfall] 30-inch concrete encased drainage pipe through the levee, 6.2 feet below the crown. Gate valves and siphon breaker in concrete box in the waterside (WS) shoulder. Concrete headwall on the WS. Pump on the landside (LS). Ramp on LS "O" Street. (30-inch pipe authorized under Permit No. 5695-A, 1970 - State of California, Department of Public Works Division of Highways [Caltrans]) [Additional Reference(s): DWR Levee Log, 1993]  
FS Date: 3/6/2013

View of landward side--wide levee crown.

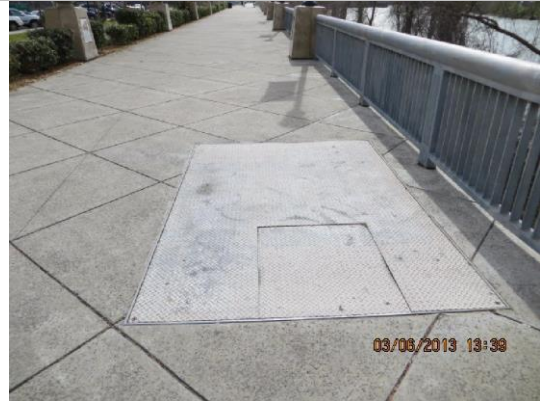
Photo 2 of 3 : UCIP\_SP\_2018\_52601\_34413.jpg

07/21/2016 Meet with City of Sacramento North Area Drainage representatives: Mick Smith and Mike Gonsalves. Mike Gonsalves mentioned that inspection completed in 2016 by Caltrans revealed structure needed some repairs. Caltrans is working at replacing/repairing pipe by 2018. (DWR UCIP – O. Magana)  
FIELD\_STRUCT\_DESC: [O Street Outfall] 30-inch concrete encased drainage pipe through the levee, 6.2 feet below the crown. Gate valves and siphon breaker in concrete box in the waterside (WS) shoulder. Concrete headwall on the WS. Pump on the landside (LS). Ramp on LS "O" Street. (30-inch pipe authorized under Permit No. 5695-A, 1970 - State of California, Department of Public Works Division of Highways [Caltrans]) [Additional Reference(s): DWR Levee Log, 1993]  
FS Date: 3/6/2013

Valve box located along walkway on levee crown.

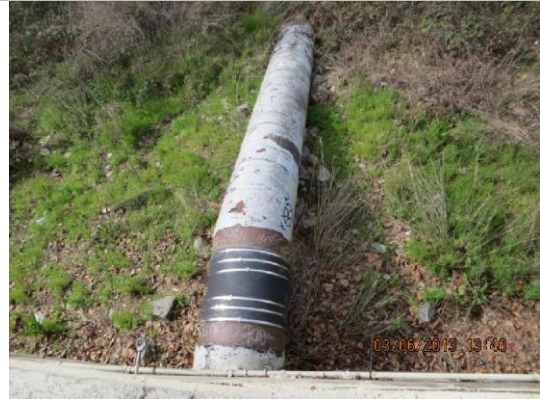
Photo 3 of 3 : UCIP\_SP\_2018\_52601\_34412.jpg

07/21/2016 Meet with City of Sacramento North Area Drainage representatives: Mick Smith and Mike Gonsalves. Mike Gonsalves mentioned that inspection completed in 2016 by Caltrans revealed structure needed some repairs. Caltrans is working at replacing/repairing pipe by 2018. (DWR UCIP – O. Magana)  
FIELD\_STRUCT\_DESC: [O Street Outfall] 30-inch concrete encased drainage pipe through the levee, 6.2 feet below the crown. Gate valves and siphon breaker in concrete box in the waterside (WS) shoulder. Concrete headwall on the WS. Pump on the landside (LS). Ramp on LS "O" Street. (30-inch pipe authorized under Permit No. 5695-A, 1970 - State of California, Department of Public Works Division of Highways [Caltrans]) [Additional Reference(s): DWR Levee Log, 1993]  
FS Date: 3/6/2013

View of pipe crossing through floodwall--waterward side.

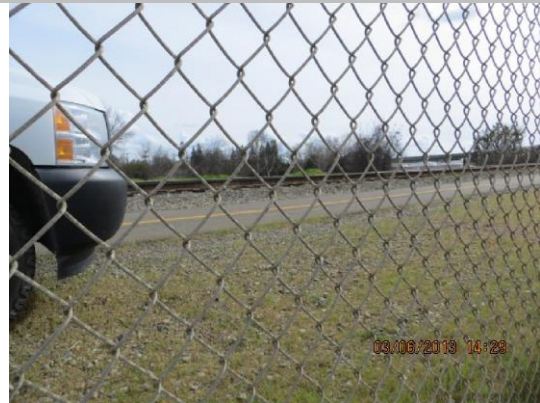
Photo 1 of 3 : UCIP\_SP\_2018\_41425\_34145.jpg

View of railroad and bike path located on levee crown--wide levee.

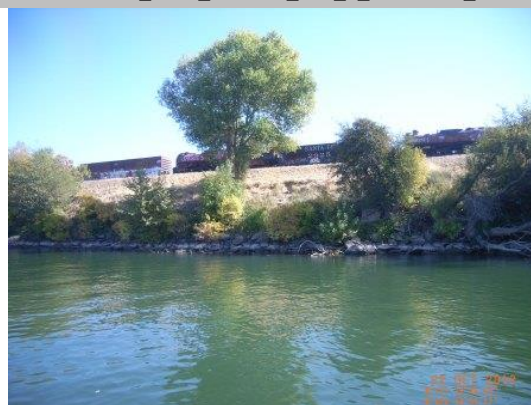
Photo 1 of 2 : SP\_2018\_NA0005\_251\_1\_20180319\_00001.jpg

LM Start	1.31	Rating **	M	Issue No.	1
LM End	1.39	Issue Type +	Ma	Location *	WS
Category	Supplemental			GPS Latitude/Longitude	
				Start	End
Item	2015 USACE Erosion Survey, DRAFT			38.573169 °	38.572277 °
				-121.511998 °	-121.513063 °
DWR ID	DWR_NA0005_01_s _ 2016_1				
Comment Code					
Inspector Comment					
2008 - Oversized levee, should be repaired under maintenance. 2009 - Shallow slumps at the mid bank. 2010 - Some minor erosion at the toe, likely from wave wash. Some new shallow slumps. 2011 - One new tree has fallen. 2013 - Erosion continues on the slope surface, site extended upstream. 2015: No observed changes. [2015 Site ID: SAC_58-5_L]

USACE 2013 Photo #1

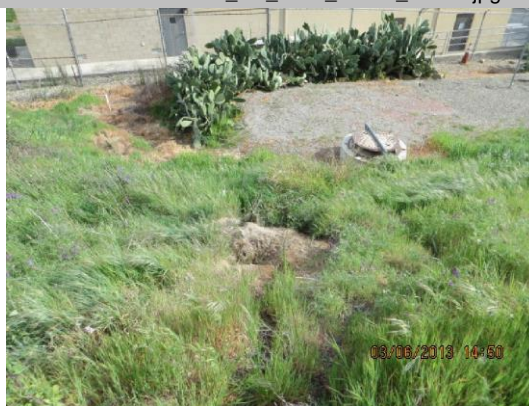
Photo 1 of 2 : UCIP\_SP\_2018\_49767\_34067.jpg

Comment Code					
Inspector Comment					
FS_ID:49767 DS_ID:21580 EP_NO: N/A Repair Type: Non-Urgent Crossing Status: Found UCIP Comments: 07/21/2016 Meet with City of Sacramento North Area Drainage representatives: Mick Smith and Mike Gonsalves. No Additional information was made available regarding the fate of this crossing. (DWR UCIP – O. Magana) 03/06/2013 Dense vegetation limits the inspector's visibility to identify signs of pipe failure (leaks) along the waterward and landward slope. Recommend removing vegetation along pipe alignment to conduct proper inspection of structure and appurtenances. (DWR UCIP - O. Magana) FIELD_STRUCT_DESC: [SUMP 1] 1 of 3: 6-inch steel water line through the levee, 8 feet below the crown. Gate valves located on the waterside (WS) slope. Manhole located on landside (LS) berm. [Additional Reference(s): DWR Levee Log, 1993] FS Date: 3/6/2013

View of landward side where crossing should be running through.

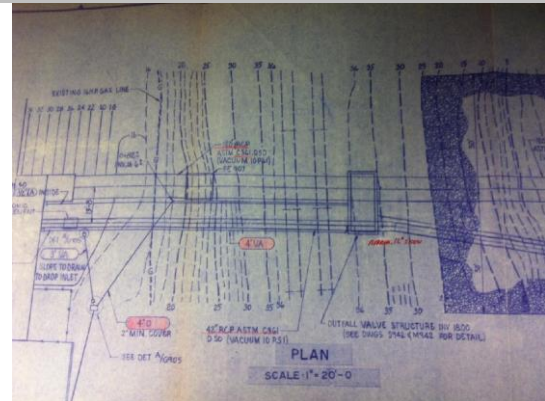
Photo 1 of 3 : UCIP\_SP\_2018\_49778\_34024.jpg

DWG showing 42-inch and 120-inch pipes through levee and connection to outfall valve structure.

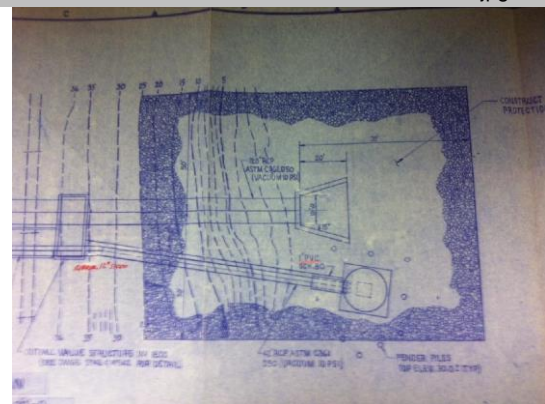
Photo 2 of 3 : UCIP\_SP\_2018\_49778\_34027.jpg

Rip rap protection around outfall structure for 42-inch and 120-inch pipes.

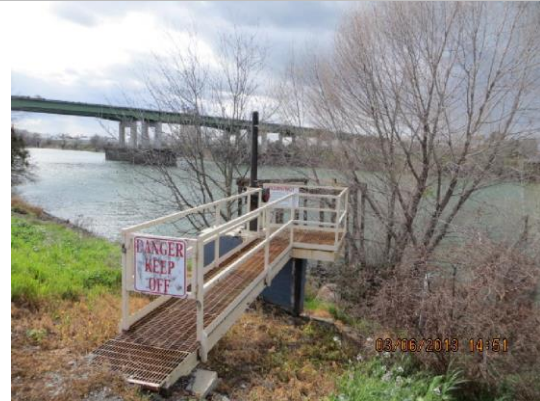
Photo 3 of 3 : UCIP\_SP\_2018\_49778\_34025.jpg

Walkway present on waterward shoulder.

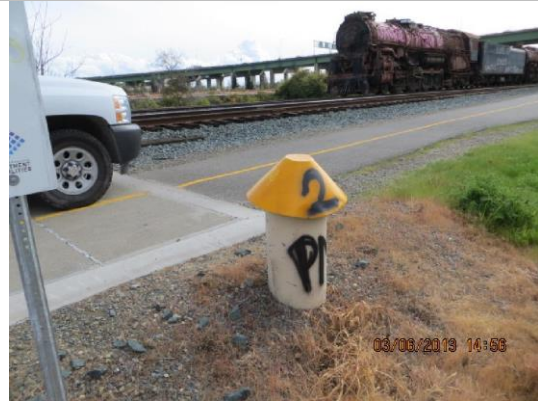
Photo 1 of 3 : UCIP\_SP\_2018\_49958\_34051.jpg

View of levee crown--outlet valve structure located along bike path and siphon breaker on waterward shoulder.

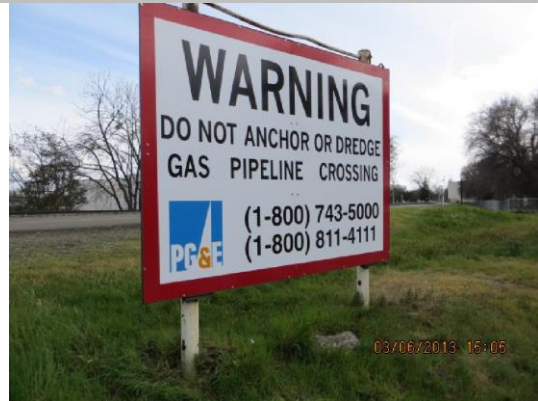
Photo 1 of 3 : UCIP\_SP\_2018\_32883\_59502.jpg

PG&E warning gas line crossing--waterward side view.

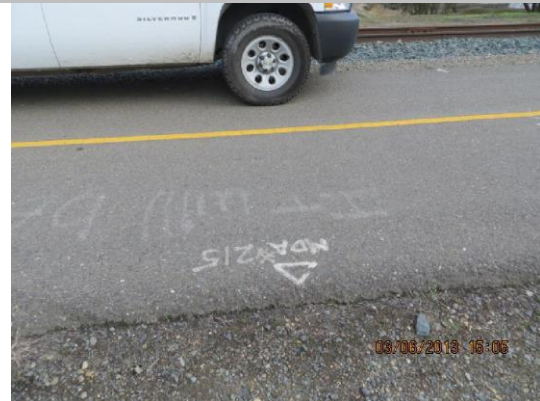
Photo 3 of 3 : UCIP\_SP\_2018\_32883\_59500.jpg

View of levee crown (trail) near waterward shoulder edge.

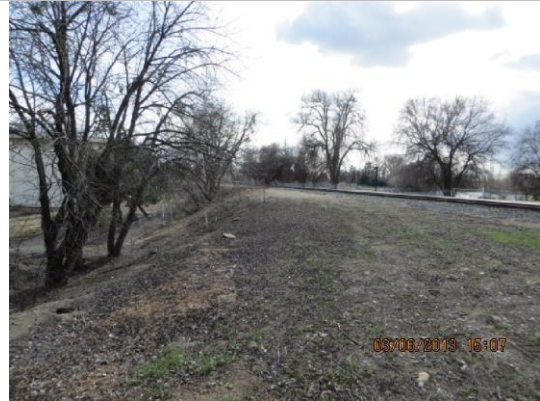
Photo 1 of 3 : UCIP\_SP\_2018\_41442\_59560.jpg

View of crossing approximately 110 feet downstream--stand pipes located on landward shoulder.

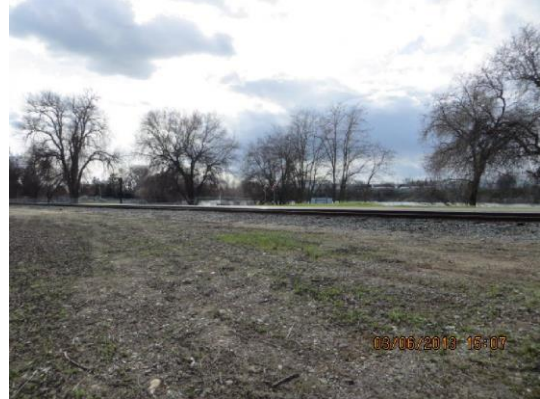
Photo 2 of 3 : UCIP\_SP\_2018\_41442\_59559.jpg

View of crossing approximately 110 feet downstream--large sign located on waterward slope.

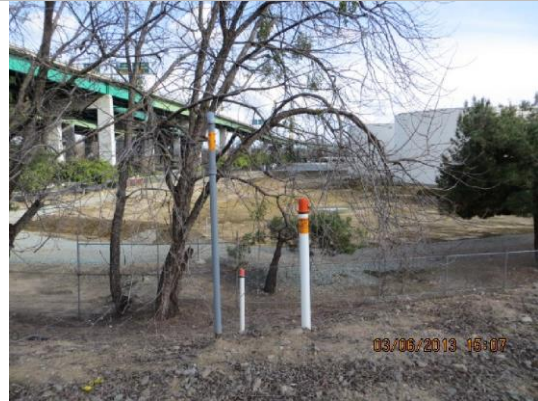
Photo 3 of 3 : UCIP\_SP\_2018\_41442\_59558.jpg

View of stand pipes located on landward side.

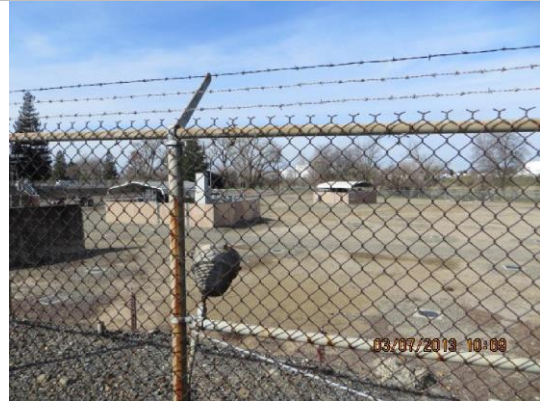
Photo 1 of 3 : UCIP\_SP\_2018\_41282\_59575.jpg

Structures present inside lot--site of Ozone Injection and Soil Vapor Extration System for the former Tosco Bulk Fuel.

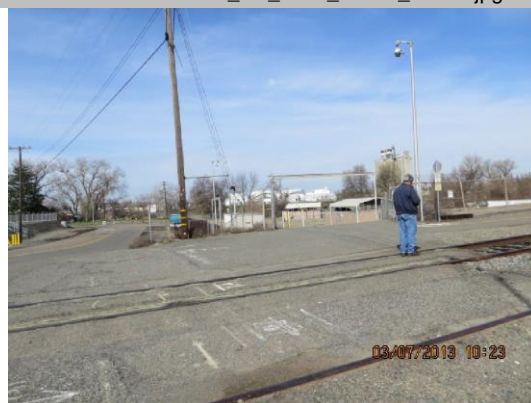
Photo 1 of 3 : UCIP\_SP\_2018\_41427\_59507.jpg

View of wide levee crown--old railroad tracks, former Tosco Bulk Fuel Terminal #3493, utility poles, and fire hydrant.

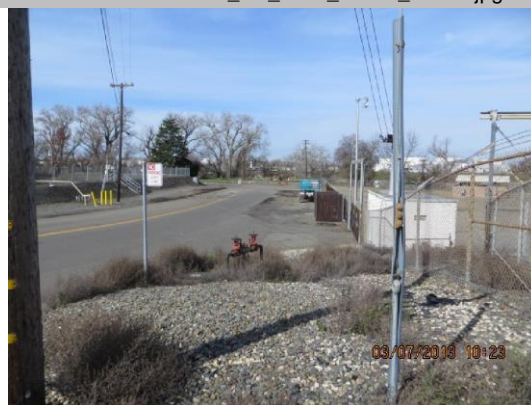
Photo 2 of 3 : UCIP\_SP\_2018\_41427\_59506.jpg

Backflow prevention device on shoulder.

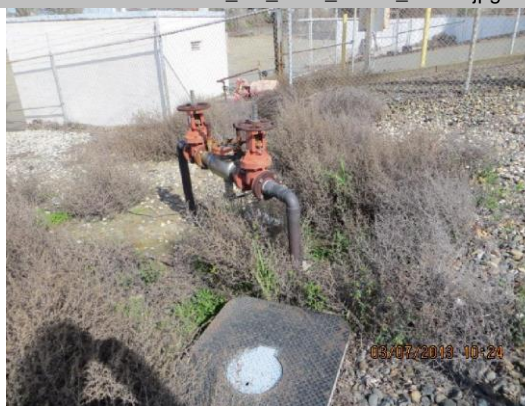
Photo 3 of 3 : UCIP\_SP\_2018\_41427\_59505.jpg

Close up of positive closure device.

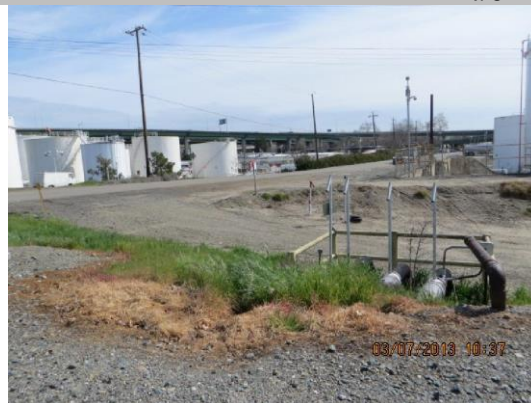
Photo 1 of 3 : UCIP\_SP\_2018\_41452\_59525.jpg

View of crossings from levee shoulder.

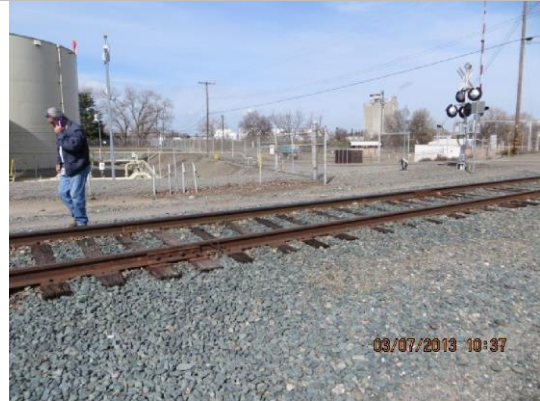
Photo 3 of 3 : UCIP\_SP\_2018\_41452\_59523.jpg

Pipe markers visible along chain link fence on waterward side.

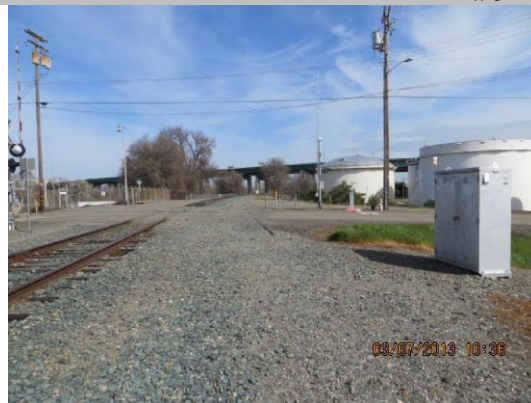
Photo 1 of 3 : UCIP\_SP\_2018\_41448\_59511.jpg

View of levee crown looking upstream--rail road traffic signal box located on right side.

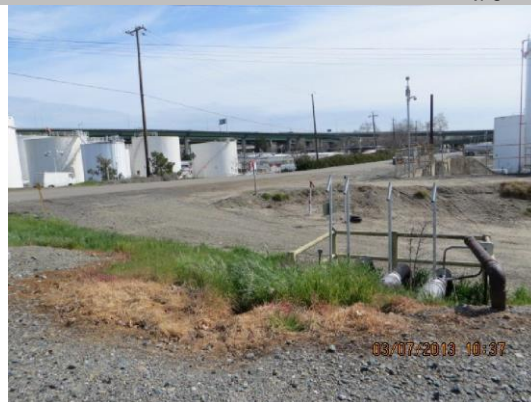
Photo 2 of 3 : UCIP\_SP\_2018\_41448\_59510.jpg

Overview of 4-10 inch lines through levee--landward side.

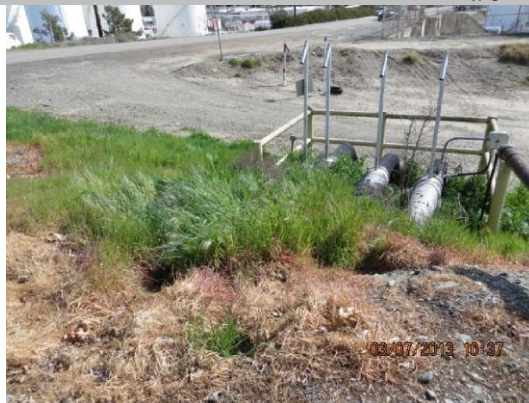
Photo 1 of 3 : UCIP\_SP\_2018\_41449\_59518.jpg

View of 4-10 inch pipes through levee located on landward side.

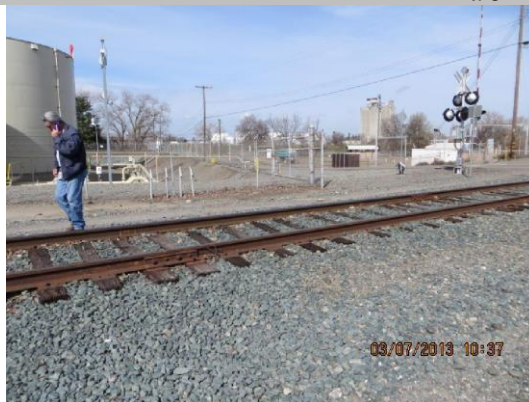
Photo 2 of 3 : UCIP\_SP\_2018\_41449\_59517.jpg

View of waterward side--markers visible along chain link fence.

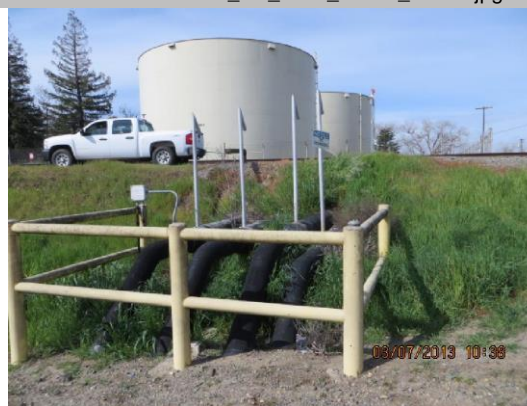
Photo 3 of 3 : UCIP\_SP\_2018\_41449\_59516.jpg

Pipes protected by metal post fence--landward side.

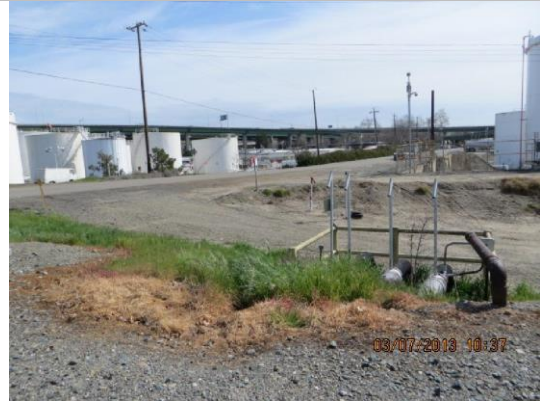
Photo 1 of 3 : UCIP\_SP\_2018\_48322\_59521.jpg

View multiple crossings visible on landward side.

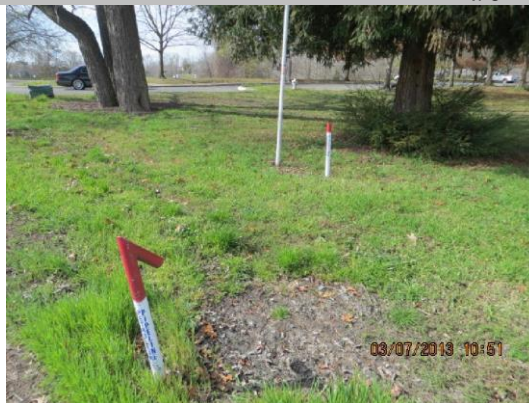
Photo 1 of 3 : UCIP\_SP\_2018\_41457\_59529.jpg

View of waterard side--markers visible through levee.

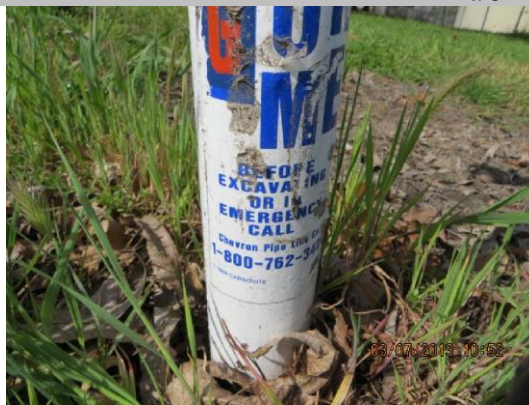
Photo 2 of 3 : UCIP\_SP\_2018\_41457\_59528.jpg

LM Start	1.78	Rating **	M	Issue No.	146
LM End	1.78	Issue Type +	En	Location *	
Category	Supplemental			GPS Latitude/Longitude	
				Start	End
Item	DWR UCIP Field Study			38.567352 °	38.567352 °
				-121.516102 °	-121.516102 °
DWR ID					
Comment Code					
Inspector Comment					
FS_ID:41457 DS_ID:21576 EP_NO: 4914 Repair Type: Non-Urgent Crossing Status: Indicator Found UCIP Comments: 03/07/2013 Need records confirming crossing is free of leaks. (DWR UCIP - O. Magana) FIELD_STRUCT_DESC: 8-inch steel oil product line through the levee, 5 feet below the crown and along the waterside (WS) to Levee Mile 2.41, for river crossing under the channel. (8-inch line authorized under Permit No. 4914, -A, -B, -C, 1965 - Standard Oil Co.) [Additional Reference(s): DWR Levee Log, 1993] FS Date: 3/7/2013

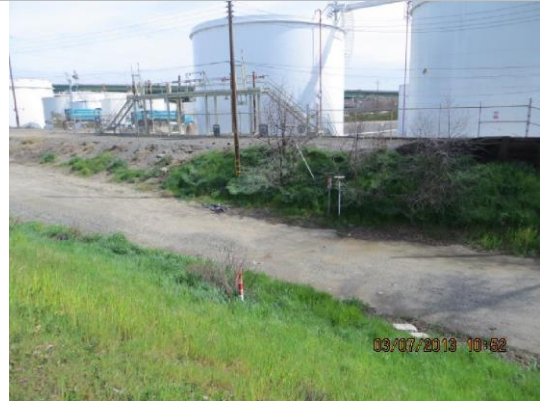
Photo 3 of 3 : UCIP\_SP\_2018\_41457\_59527.jpg

LM Start	1.78	Rating **	M	Issue No.	146 (cont)	
LM End	1.78	Issue Type +	En	Location *		
Category	Supplemental			GPS Latitude/Longitude		
				Start	End	
Item	DWR UCIP Field Study			38.567352 °	38.567352 °	
				-121.516102 °	-121.516102 °	
DWR ID						
Comment Code						
Inspector Comment						
FS_ID:41457 DS_ID:21576 EP_NO: 4914 Repair Type: Non-Urgent Crossing Status: Indicator Found UCIP Comments: 03/07/2013 Need records confirming crossing is free of leaks. (DWR UCIP - O. Magana) FIELD_STRUCT_DESC: 8-inch steel oil product line through the levee, 5 feet below the crown and along the waterside (WS) to Levee Mile 2.41, for river crossing under the channel. (8-inch line authorized under Permit No. 4914, -A, -B, -C, 1965 - Standard Oil Co.) [Additional Reference(s): DWR Levee Log, 1993] FS Date: 3/7/2013

Markers visible on landward side.

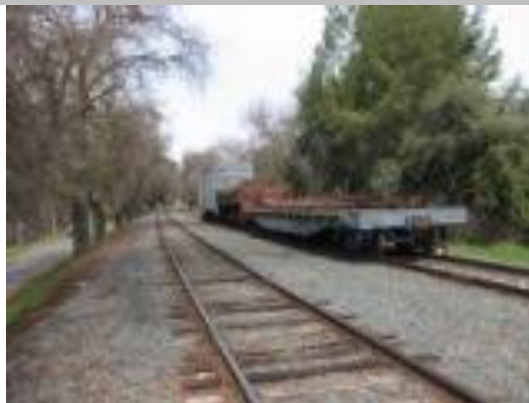
Photo 1 of 4 : SP\_2018\_NA0005\_251\_7\_20180319\_00004.jpg

LM Start	<b>1.95</b>	Rating **	A/W	Issue No.	<b>7 (cont)</b>
LM End	<b>2.34</b>	Issue Type +	En	Location *	CR

The railroad cars remain on the levee crown. Spring 2013

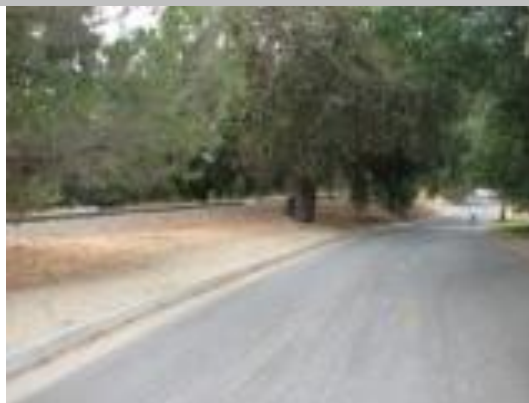
Photo 2 of 4 : SP\_2018\_NA0005\_251\_7\_20180319\_00005.jpg

Railroad tracks are on levee crown. The street is to the boat ramp.

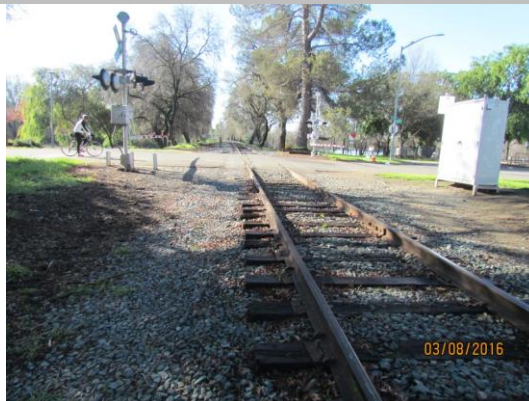
Photo 3 of 4 : SP\_2018\_NA0005\_251\_7\_20180319\_00006.jpg

View of the railroad tracks on the crown of the levee looking downstream at levee mile 1.95. Spring 2016.

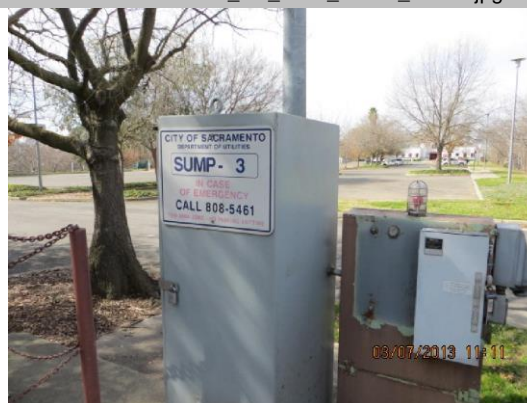
Photo 2 of 3 : UCIP\_SP\_2018\_41430\_72756.jpg

Comment Code						
Inspector Comment						
FS_ID:41430 DS_ID:21613 EP_NO: 7434 Repair Type: Non-Urgent Crossing Status: Indicator Found UCIP Comments: 03/07/2013 2 manholes and sump pump present. Need to update description to confirm if this permit is for Sump-3. (DWR UCIP - O. Magana) FIELD_STRUCT_DESC: [Sump 3] 4-inch sanitary sewer force main 0.375-inch steel with 0.125-inch mortar liner and asphalt coated on the outside through the levee at an unknown depth below the levee crown to serve Miller Park area. Line runs along the center of the levee for approximately 1700 feet. City of Sacramento Dept. of Utilities, Sump 3 lift station, contact information in case of emergency - 916-808-5461. (6- inch pipe authorized under Permit No. 7434, City of Sacramento-1972) FS Date: 3/7/2013

Sump pump station 3.

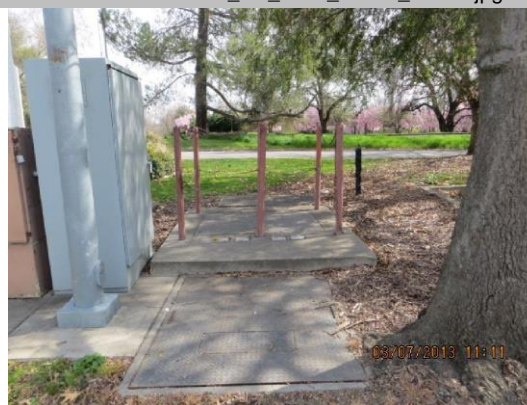
Photo 3 of 3 : UCIP\_SP\_2018\_41430\_72755.jpg

Service vault visible on levee crown.

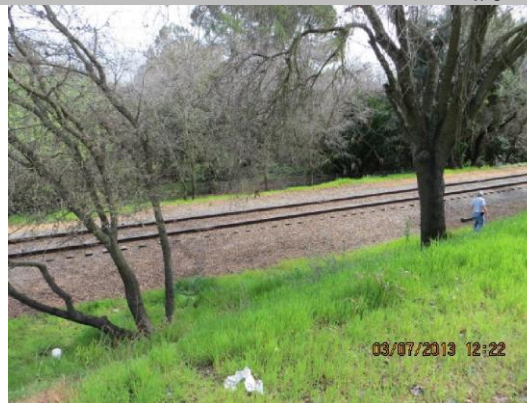
Photo 2 of 2 : UCIP\_SP\_2018\_41293\_72759.jpg

Comment Code						
Inspector Comment						
FS_ID:41293						
DS_ID:24921						
EP_NO: N/A						
Repair Type: Non-Urgent						
Crossing Status: Indicator Found						
UCIP Comments: 07/21/2016 Meet with City of Sacramento North Area						
Drainage representatives: Mick Smith and Mike Gonsalves. Pipe						
section along the LS levee removed and the pipe section through the						
levee was grouted. Pipe is linked to PI issue, issue was coordinated						
with the CVFPB. No permit was issued. (DWR UCIP – O. Magana)						
03/06/2013 Need to contact owner to determine type of crossing and						
status. Need to find out the alignment of crossing. (DWR UCIP - O.						
Magana)						
FIELD_STRUCT_DESC: *ABANDONED* 1 of 4. Crossing found						
through railroad/levee visible on landside (LS).						
FS Date: 3/6/2013

View of landward side.

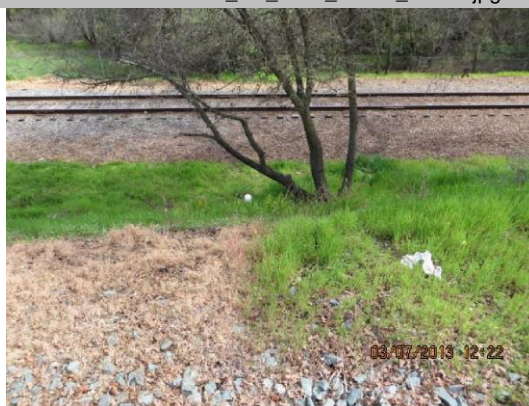
Photo 1 of 2 : UCIP\_SP\_2018\_41294\_72762.jpg

Comment Code					
Inspector Comment					
FS_ID:41294					
DS_ID:24922					
EP_NO: N/A					
Repair Type: Non-Urgent					
Crossing Status: Indicator Found					
UCIP Comments: 07/21/2016 Meet with City of Sacramento North Area					
Drainage representatives: Mick Smith and Mike Gonsalves. Pipe					
section along the LS levee removed and the pipe section through the					
levee was grouted. Pipe is linked to PI issue, issue was coordinated					
with the CVFPB. No permit was issued. (DWR UCIP – O. Magana)					
03/06/2013 Need to contact owner to determine type of crossing and					
status. Need to find out the alignment of crossing. (DWR UCIP - O.					
Magana)					
FIELD_STRUCT_DESC: *ABANDONED* 2 of 4. Crossing found					
through railroad/levee visible on landside (LS).					
FS Date: 3/6/2013

PVC pipe through levee.

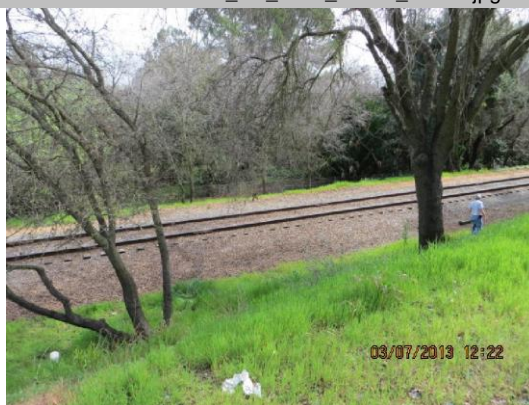
Photo 2 of 2 : UCIP\_SP\_2018\_41294\_72761.jpg

View of landward side.

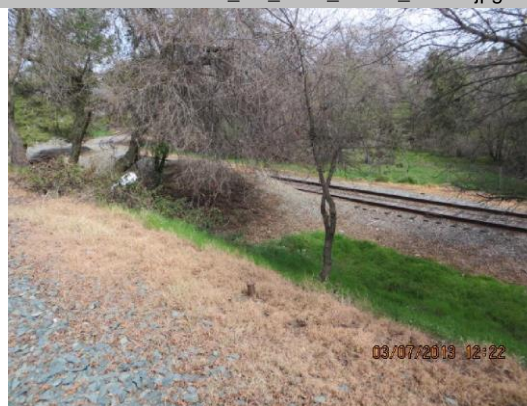
Photo 1 of 2 : UCIP\_SP\_2018\_41295\_72764.jpg

Comment Code					
Inspector Comment					
FS_ID:41295 DS_ID:24923 EP_NO: N/A Repair Type: Non-Urgent Crossing Status: Indicator Found UCIP Comments: 07/21/2016 Meet with City of Sacramento North Area Drainage representatives: Mick Smith and Mike Gonsalves. Pipe section along the LS levee removed and the pipe section through the levee was grouted. Pipe is linked to PI issue, issue was coordinated with the CVFPB. No permit was issued. (DWR UCIP – O. Magana) 03/06/2013 Need to contact owner to determine type of crossing and status. Need to find out the alignment of crossing. (DWR UCIP - O. Magana) FIELD_STRUCT_DESC: *ABANDONED* 3 of 4. Crossing found through railroad/levee visible on landside (LS). FS Date: 3/6/2013

View of landward side.

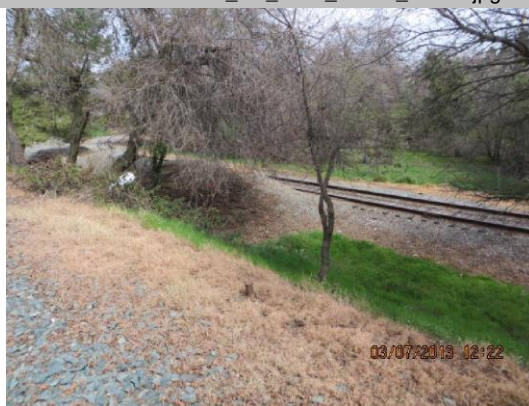
Photo 1 of 2 : UCIP\_SP\_2018\_38827\_72766.jpg

Comment Code					
Inspector Comment					
FS_ID:38827					
DS_ID:24924					
EP_NO: N/A					
Repair Type: Non-Urgent					
Crossing Status: Indicator Found					
UCIP Comments: 07/21/2016 Meet with City of Sacramento North Area					
Drainage representatives: Mick Smith and Mike Gonsalves. Pipe					
section along the LS levee removed and the pipe section through the					
levee was grouted. Pipe is linked to PI issue, issue was coordinated					
with the CVFPB. No permit was issued. (DWR UCIP – O. Magana)					
03/06/2013 Need to contact owner to determine type of crossing and					
status. Need to find out the alignment of crossing. (DWR UCIP - O.					
Magana)					
FIELD_STRUCT_DESC: *ABANDONED* 4 of 4. Crossing found					
through railroad/levee visible on landside (LS).					
FS Date: 3/6/2013

View of landward side.

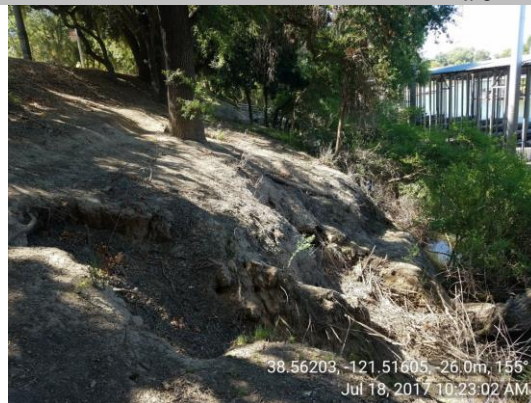
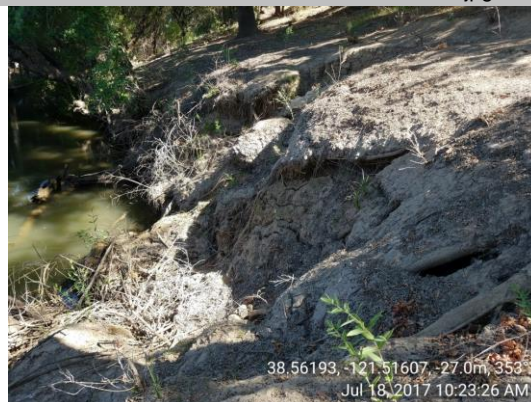
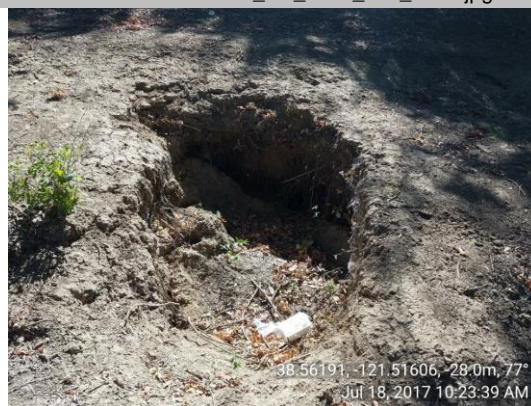
Photo 1 of 3 : LEVAL\_SP\_2018\_492\_1797.jpg

Repair Type: Erosion

LM Start	2.15	Rating **	A/W	Issue No.	81 (cont)	
LM End		Issue Type +	Ma	Location *		
Category	Supplemental			GPS Latitude/Longitude		
				Start	End	
Item	2017 Storm Damage			38.562070 °		
				-121.515770 °		
DWR ID	DWR_NA0005_01_f_2017_81					
Comment Code						
Inspector Comment						
Levee Evaluation Comments						
Description:						
Site ID No:492						
Site Designation:SCDU-07						
Repair Type: Erosion						
Rating:Serious						
Field Date:7/18/2017						
Notes: Erosion length = 80 feet						
City will repair this section summer 2018.

City will repair this section summer 2018.

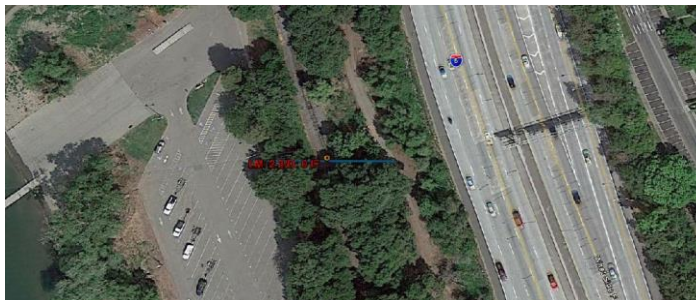
Photo 1 of 1 : UCIP\_SP\_2018\_41431\_72800.jpg

Comment Code					
Inspector Comment					
FS_ID:41431					
DS_ID:24925					
EP_NO: N/A					
Repair Type: Non-Urgent					
Crossing Status: Indicator Found					
UCIP Comments: 07/21/2016 Meet with City of Sacramento North Area Drainage representatives: Mick Smith and Mike Gonsalves. Pipe might be abandoned. No additional information was provided by LMA. (DWR UCIP – O. Magana)					
03/06/2013 Need to coordinate with owner to determine status of crossing. (DWR UCIP - O. Magana)					
FIELD_STRUCT_DESC: 18-inch drainage pipe of unknown material through the levee at an unknown depth below the levee crown. Crossing information was obtained from the City of Sacramento GIS records.					
FS Date: 3/6/2013

Approximate alignment through levee provided by the City of Sacramento GIS.

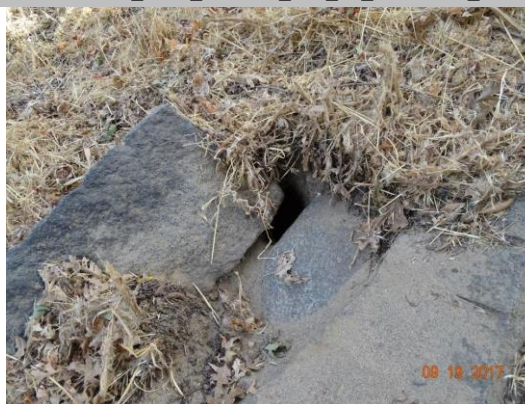
Photo 1 of 1 : SP\_2018\_NA0005\_251\_82\_20180319\_00020.jpg

LM Start	2.31	Rating **	A/W	Issue No.	82
LM End	2.31	Issue Type +	Ma	Location *	WS
Category	Earthen Levee			GPS Latitude/Longitude	
				Start	End
Item	Animal Control			38.559767 °	38.559767 °
				-121.515264 °	-121.515264 °
DWR ID	DWR_NA0005_01_s_2016_82				
Comment Code					
A3 : No rodents visible, but rodent burrows visible; need to backfill and compact or grout burrows.					
Inspector Comment					
City of Sac grouted this area and will continue to monitor.

View of rodent hole on waterside slope. Fall 2017.

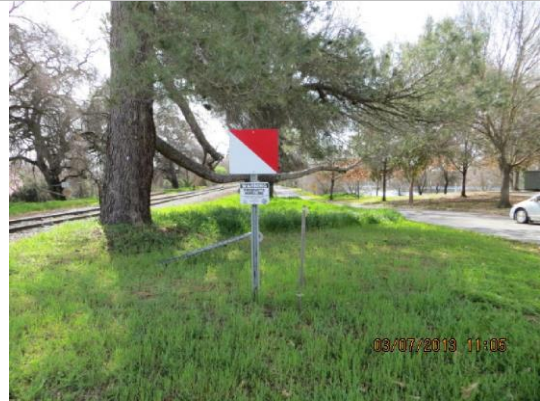
Photo 1 of 1 : UCIP\_SP\_2018\_52602\_72758.jpg

FS\_ID:52602  
DS\_ID:24917  
EP\_NO: N/A  
Repair Type: Non-Urgent  
Crossing Status: Indicator Found  
UCIP Comments: 03/07/2018 Drawings available under Permit No. 4914-C provided approximate levee crossing for dsid 24917, which crosses levee at CLM 2.34, this crossing was previously listed under CLM 1.966. Crossing description, coordinates, and CLM have been updated. Photo from 2013 of paddle marker was taken at CLM 1.966. Need to take photo of paddle marker at CLM 2.34 to update this record. If no marker is present at CLM 2.34, LMA will need to coordinate with owner about adding marker. (DWR UCIP - O. Magana)  
07/21/2016 Meet with City of Sacramento North Area Drainage representatives: Mick Smith and Mike Gonsalves. Line goes through crown, goes along WS, and then goes across channel and through West Sacramento Levees (RD0900). (DWR UCIP - O. Magana)  
03/06/2013 Need to contact owner to determine additional details-- permit, alignment, depth, and last inspection. (DWR UCIP - O. Magana)

FIELD\_STRUCT\_DESC: 8-inch steel oil product line through the levee, 3.5 feet below the levee crown. (8-inch pipe authorized under Permit No. 4914, -B, 1965 - Standard Oil Company of California, HLM 2.04; 8-inch pipe removed and replaced with new 8-inch pipe (only through RD0900 levee) authorized under Permit No. 4914-C, 2010 - Chevron Pipeline Company) [Additional Reference(s): DWR Levee Log, 2003]  
FS Date: 3/6/2013

Marker of gas line visible on levee crown next to railroad tracks.
